The 5 Digit Code for Single Button Jeep Remotes

GETTING THE JEEP REMOTE CODE ON SINGLE BUTTON REMOTES

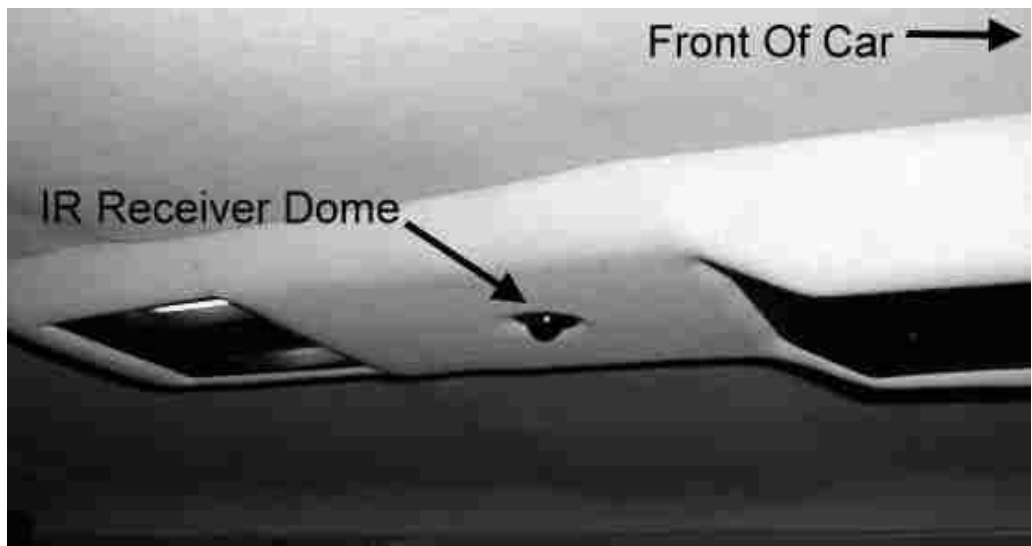
Step 1

the console above the rear view mirror. The console is lowered then two Phillips screws are removed from the receiver. After the two screws are removed from the receiver, the code can be obtained from the white paper sticker. One typical bad code obtained from overhead consoles is 52019 B, this number is printed on the circuit board by the wire harness. If this number has been reported instruct the customer to remove the receiver from the console to read the other side where the code is located. (Note that this number, 52019 contains a 9 within the 5 digits automatically indicating a bad code.)
